RAISING AND CONSERVING THE MARY ROSE

The Mary Rose Museum has been shortlisted for the 2018 European Museum of the Year award. It houses the Mary Rose hull and thousands of Tudor artefacts that were sealed under clay and silt when it sank in 1545. Technology has helped detect, rescue, resurrect and conserve the remains of Henry VIII's warship since the mission to find it began in the 1960s. Engineering writer Dominic Joyeux talked to Dr Eleanor Schofield, Head of Conservation and Collections Care, and Christopher Dobbs, Head of Interpretation and Maritime Archaeology, to find out more.

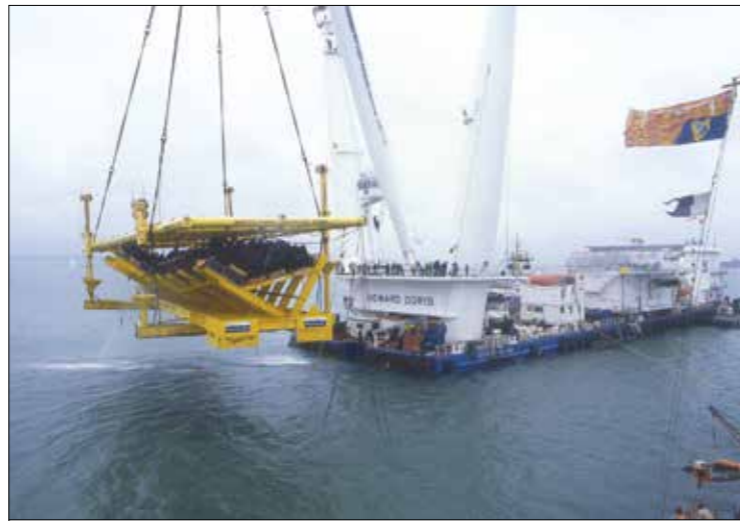
The crane lifting the *Mary Rose* hull out of the Solent, lying on its yellow cradle, is an image that millions of TV viewers retain from the memorable morning of Monday 11 October 1982 © Christopher Dobbs/Mary Rose Trust

On 11 October 1982, media gathered from all over the world and an estimated 60 million people watched the raising of the hull on television. Above the water, a giant floating crane called *Tog Mor* took the strain and transferred the hull frame onto the cradle as divers monitored the process on the seabed. The crane winched the cradle very slowly to the surface, where the hull encountered air again for the first time in 437 years.

There was an initial scare when the filming showed one corner of the frame slipping toward the hull due to a mistakenly applied strop and some securing pins. However, shortly after, the crane placed

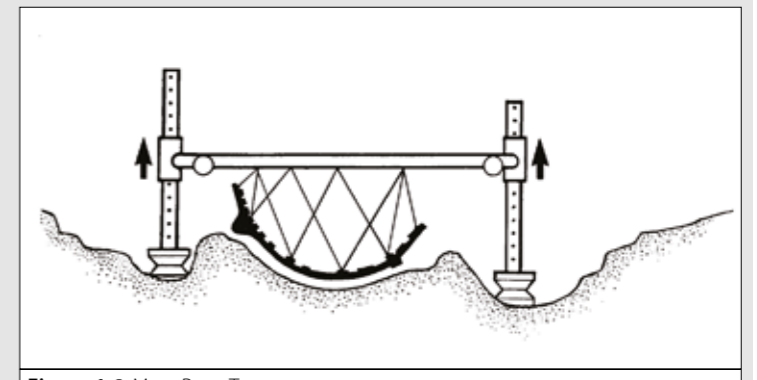
Figure 1 © Mary Rose Trust

The first step of the plan to lift the *Mary Rose* tackled the problem of 'bottom suction', whereby the ship was embedded within the silt and clay of the seabed. This was achieved using 12 hydraulic jacks raising a lifting frame slowly [Figure 1], over a period of several days, up its four legs.

A network of bolts and internal lifting wires was created, rather than the traditional salvage method of using external strops. This spread the loading of the lift across the entire structure of the hull, avoiding the need for heavy stiffening inside the hull. Each of the 67 main lifting points had a bolt passed through the hull that, when tightened down onto the internal and external spreader plates, acted as clamps to hold the hull firmly together. The salvage diving team fitted a further 103 bolts to act as additional clamps.

Once each section of the hull was wired up to the lifting frame, the hull was undercut to find the next row of backplate positions. This meant that the divers always worked under areas of the hull that were held up from above. The divers carried out this work using a combination of a water jet to cut through the hard clay with a 150-millimetre airlift to extract the spoil [Figure 2]. It was too dark and murky to see anything, so the team placed steel rods in the bolt holes that helped the divers to locate the next area by feel.

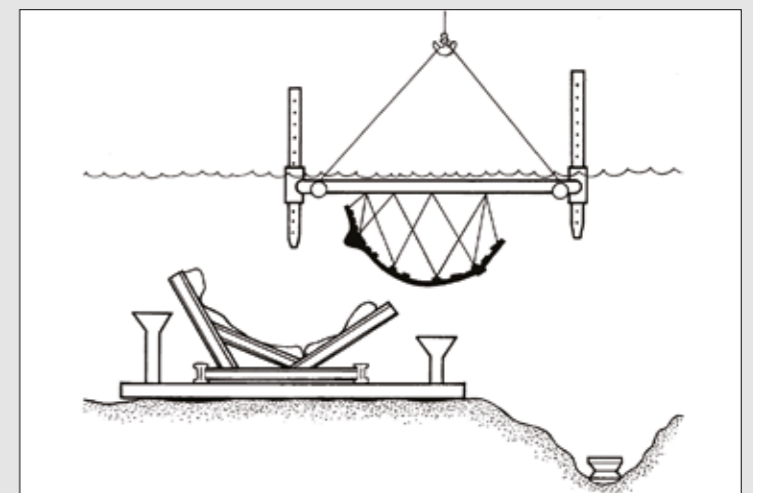
Figure 3 © Mary Rose Trust

Once the hull was hanging freely from the lifting frame, clear of the sea bed, it was transferred underwater to the cradle [Figure 3]. This supported the hull, which was sitting on inflated air bags, both below and above and meant that it was ready to lift.

Babcock Power Construction commissioned a lifting frame and a cradle to place the *Mary Rose* into. Sub-contractor Barnshaws Section Benders used section drawings made from the archaeological surveys to produce beams that formed the cradle that would hold the 35-metre-long, 14-metre-high hull of the warship. The cradle, lined with air bags, dropped down beside the hull a few days before the lifting operation began.

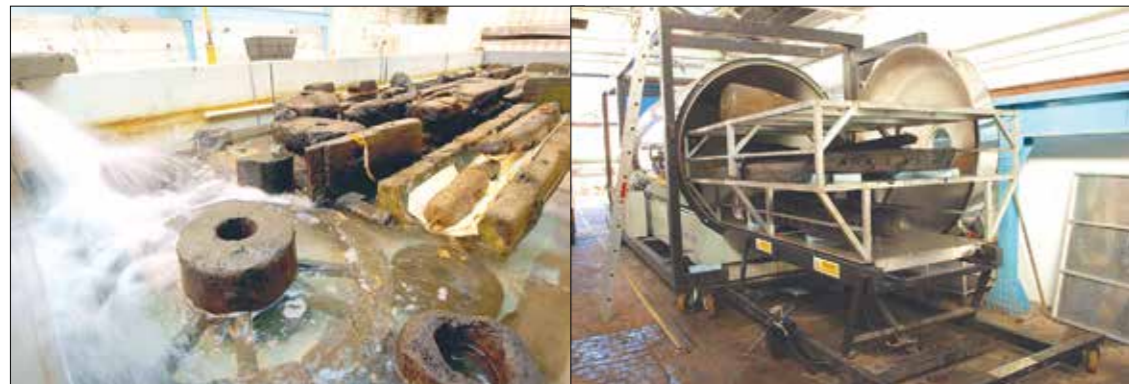
The Mary Rose team soaks the wooden artefacts in PEG for a few years and then, because they still have water in them, freeze-dry them. At six metres long, the Mary Rose freeze dryer (right) is the largest in the country. The chamber freezes the items and any remaining water turns to ice. A vacuum then applies pressure that causes the ice to sublimate and turn straight from solid to gas. Because the water comes out very quickly, it means that the dimensional changes are minimal and the process is relatively quick. The gun carriages, for example, only took three months © Mary Rose Trust

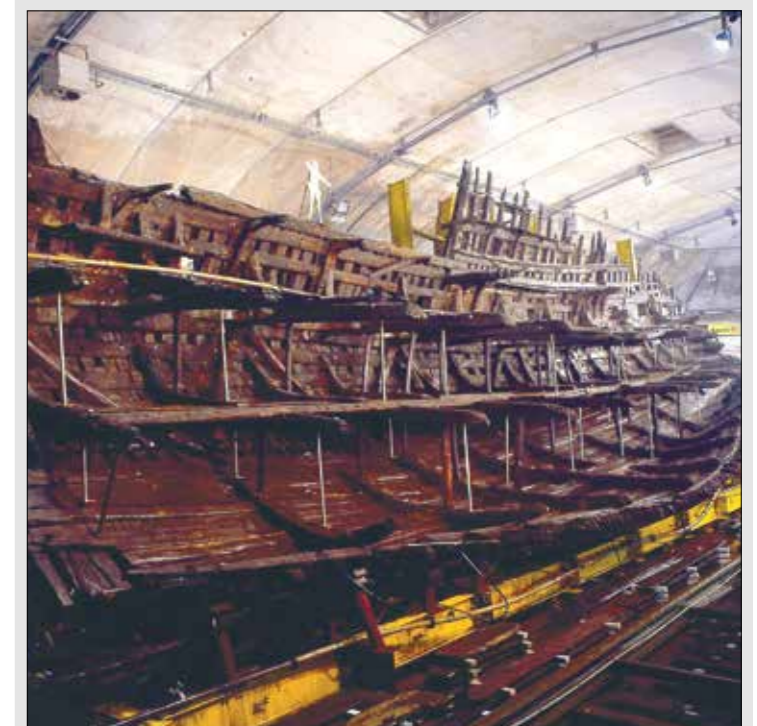
Sprays cover the Mary Rose hull with water in 1991. The hull is still on the same yellow cradle that lifted it out of the sea in 1982. It sits on the barge deck, which was cut away when it arrived at the dry dock, and rests on brick piles at a slight angle so that water and PEG solutions could drain away © Mary Rose Trust

For the first few weeks of 'passive holding', a pumping system kept the timber work of the *Mary Rose* soaked, enabling thousands of litres of seawater a minute to pass over it. The ship's conservators then switched this to freshwater and a chilling system held the water at 2°C to discourage microorganisms. They then placed a temporary building around the hull, which was to stay in place for the next 30 years to enable both public viewing and a controlled environment.

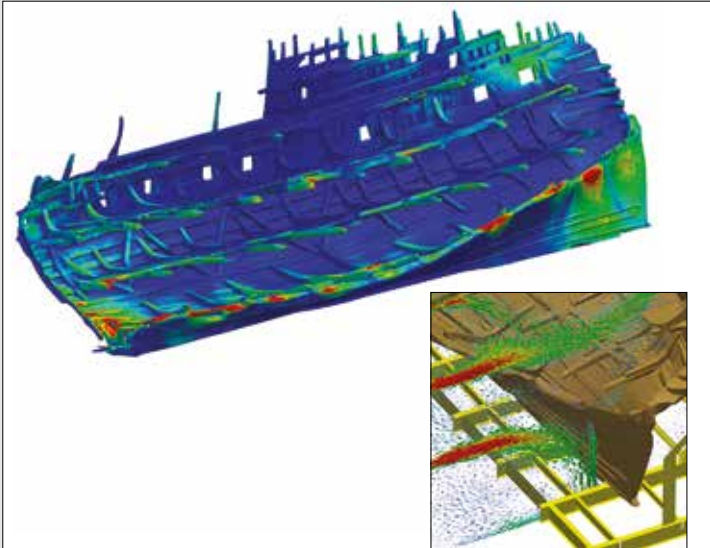
Models of the shear stress (above) and airflow velocity (below) on the inside of the hull © K8T Limited

Consulting engineers, Ramboll UK and K8T, used computer fluid dynamics (CFD) to work out the placing of ducts and extractor fans for when the *Mary Rose* switched from PEG application to air-drying in 2013. The challenge with the drying process was to get each part of the wood to receive the same amount of air at equal velocity, relative humidity and temperature as warping and cracking would occur more rapidly if they did not. A laser scan of the ship was done, which was then used in a CFD model that took in the volume of the ship hall and then fed in the inlets and proposed pathways of the drying equipment.

Repetitions of the model were done that determined air velocities, dwell times and the shear stresses caused by air movement. Using these models, it was determined that the minimum volume of air supply needed was 25 m³ (cubic metres) per second and three massive air-handling units (AHUs) each supplying 8.3 m³ per second of air were placed in the dry dock with ducts feeding the air into the ship hall and around the hull.

Further stress-testing of the model identified which nooks and crannies of the ship would be missing out on air and decided the positioning of the two 1.2-metre-diameter ducts that ran the length of the hull, which in turn dropped down to supply 14 smaller ducts threaded around the beams. The designers were aiming to supply conditioned air with a maximum velocity of 0.25 m³ per second adjacent to the hull. In order to maximise the AHU's air dehumidification, the chilled air was supplied at 2°C with the ability to rise to 6°C for the main part of the building.

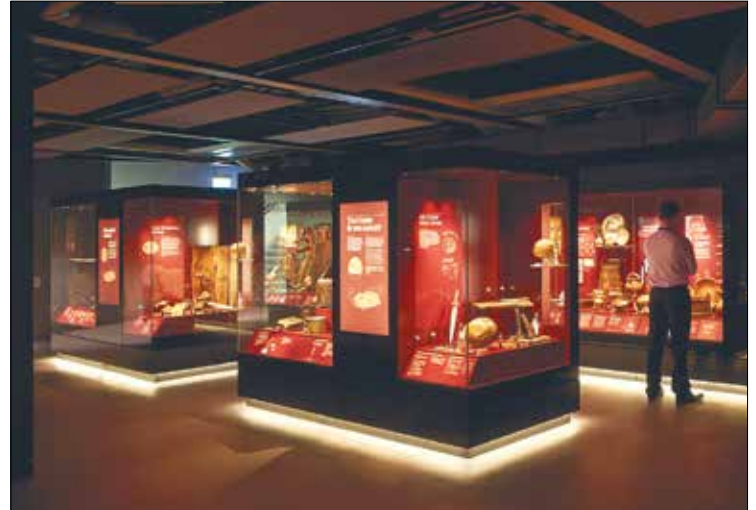
Museum display units often have a system of humidity control within the cases. The *Mary Rose* Museum has a micro-air-conditioning system for its display cases, each independent of the others, which are in turn connected to the chilled water system. The museum staff set the cases to 55% humidity and 19°C, which is typical for storing organic artefacts © Mary Rose Trust
